January 25, 2018

SUBJ: EPA Asbestos Removal at 110 Potts Street

## REMOVAL ACTION STATUS REPORT DAVIDSON ASBESTOS

**Property Address:** 110 Potts Street, Davidson, Mecklenburg County, North Carolina

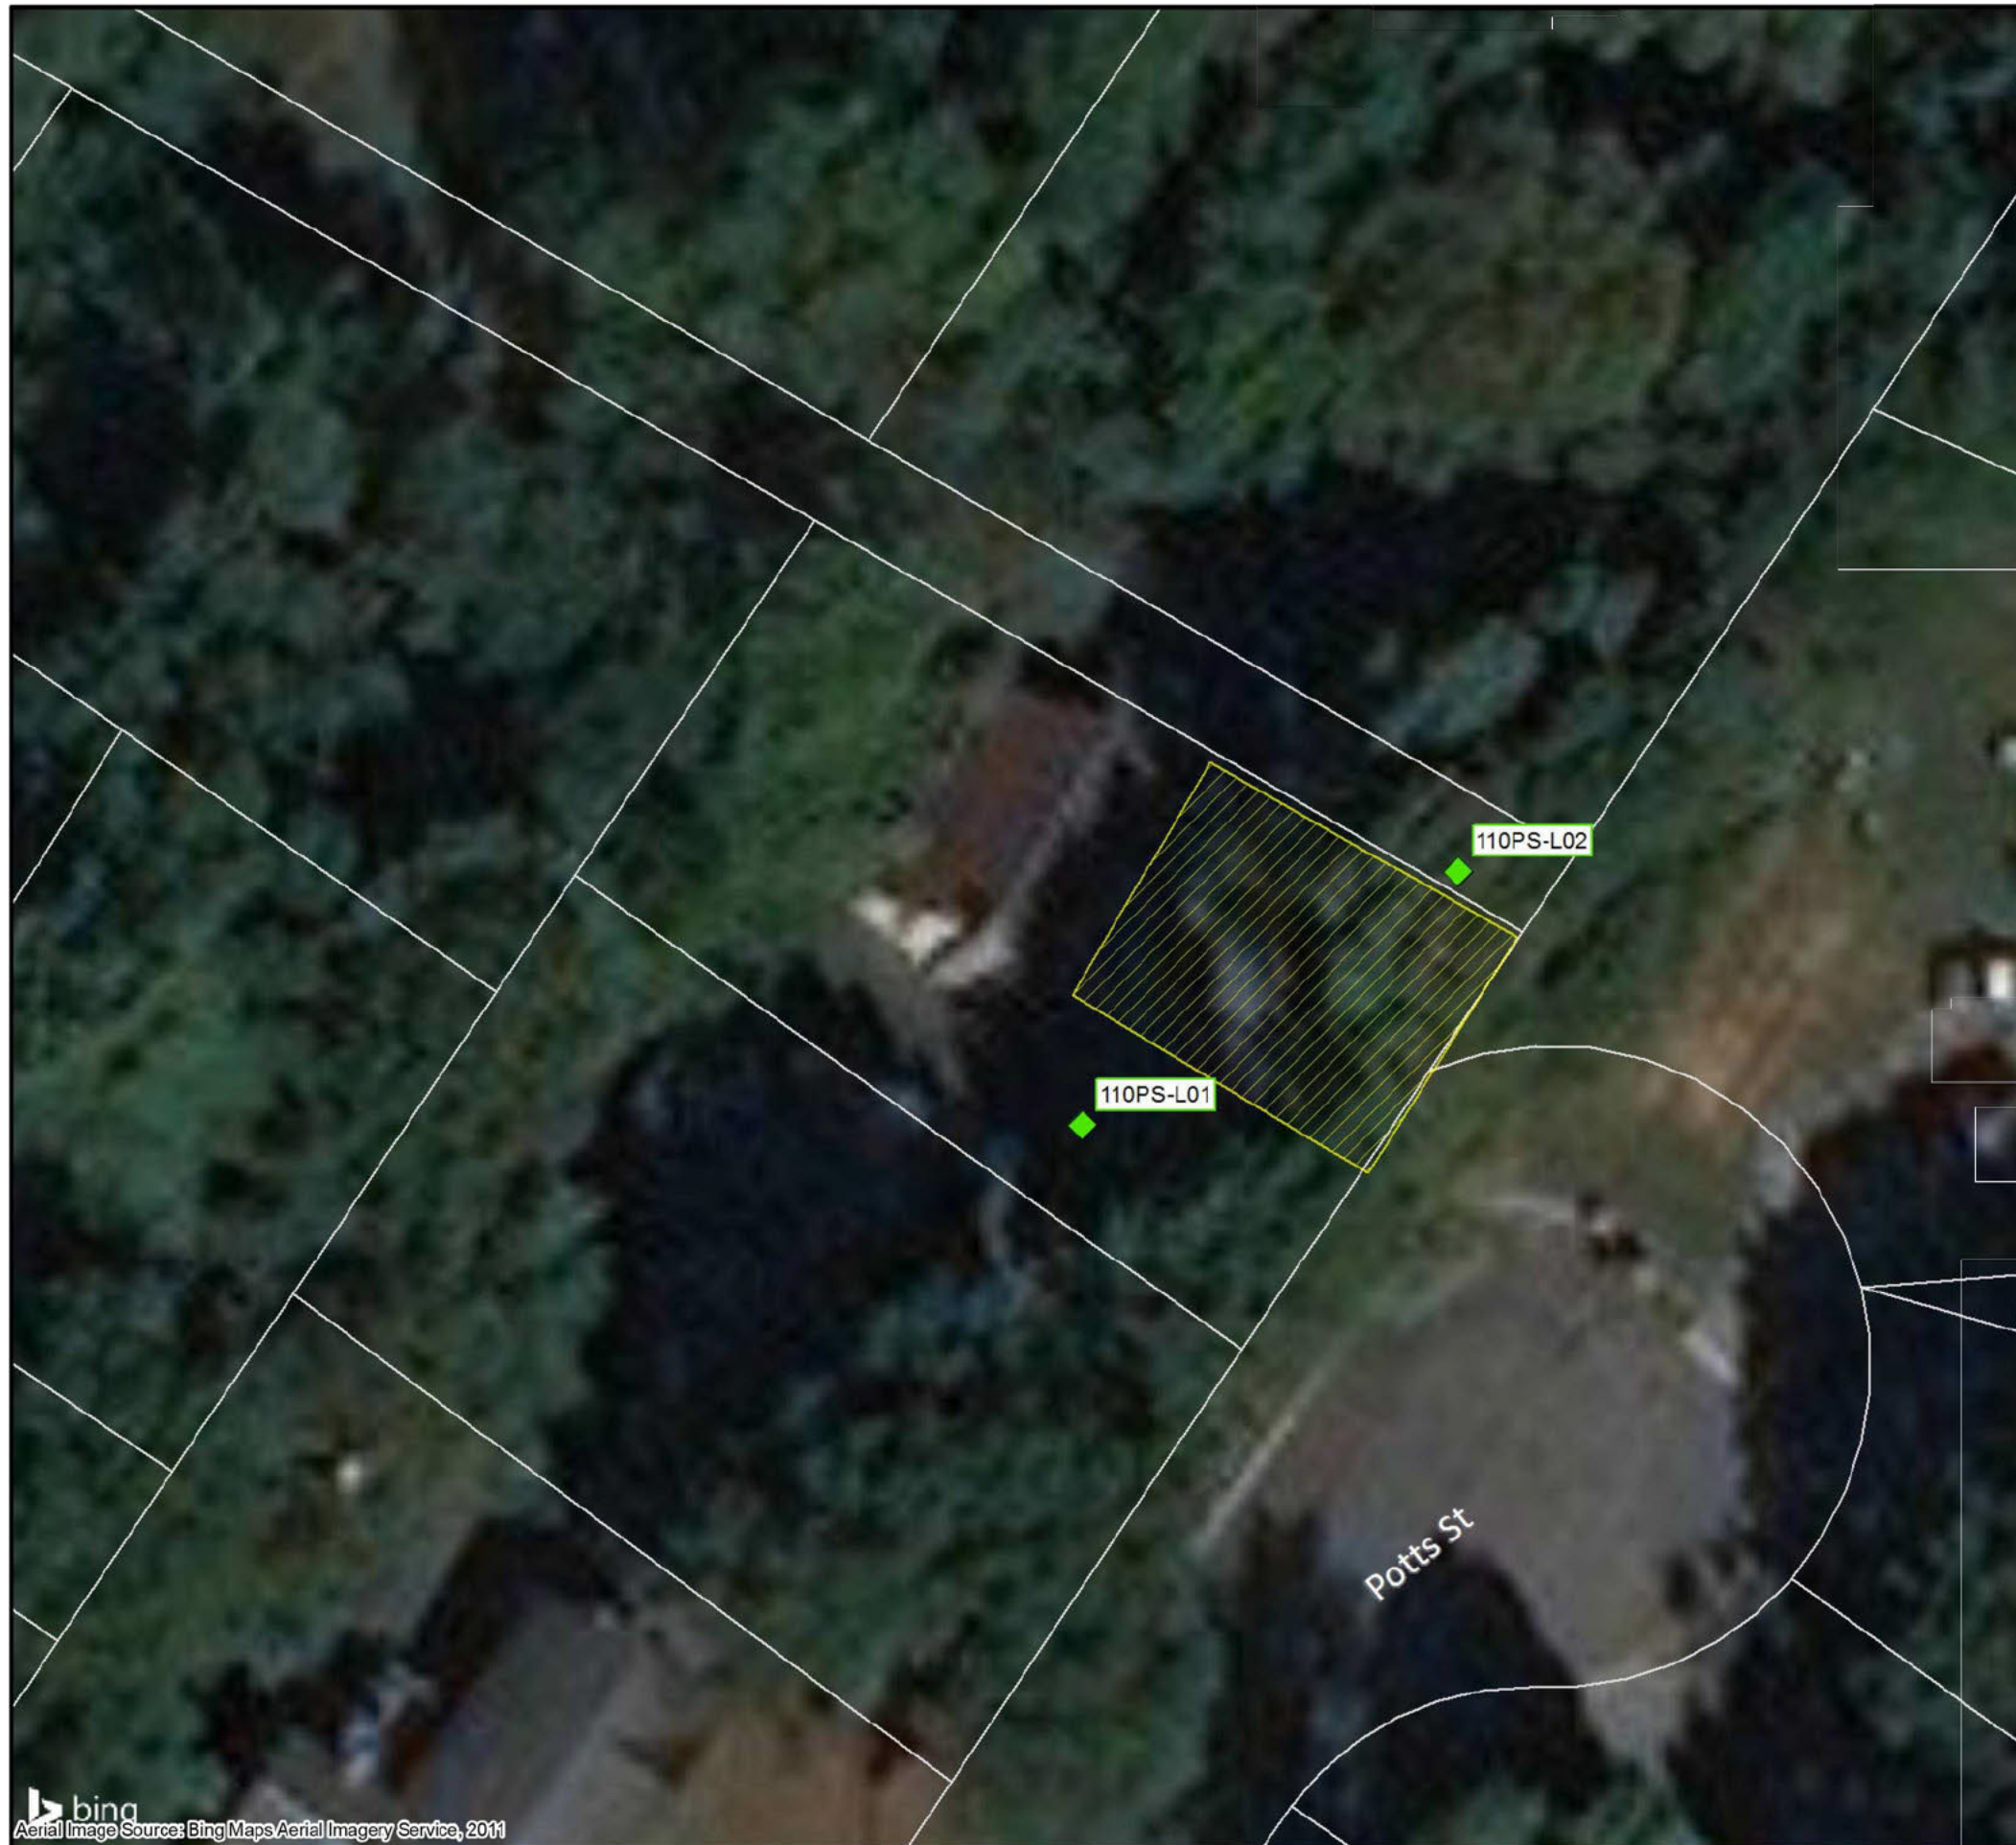
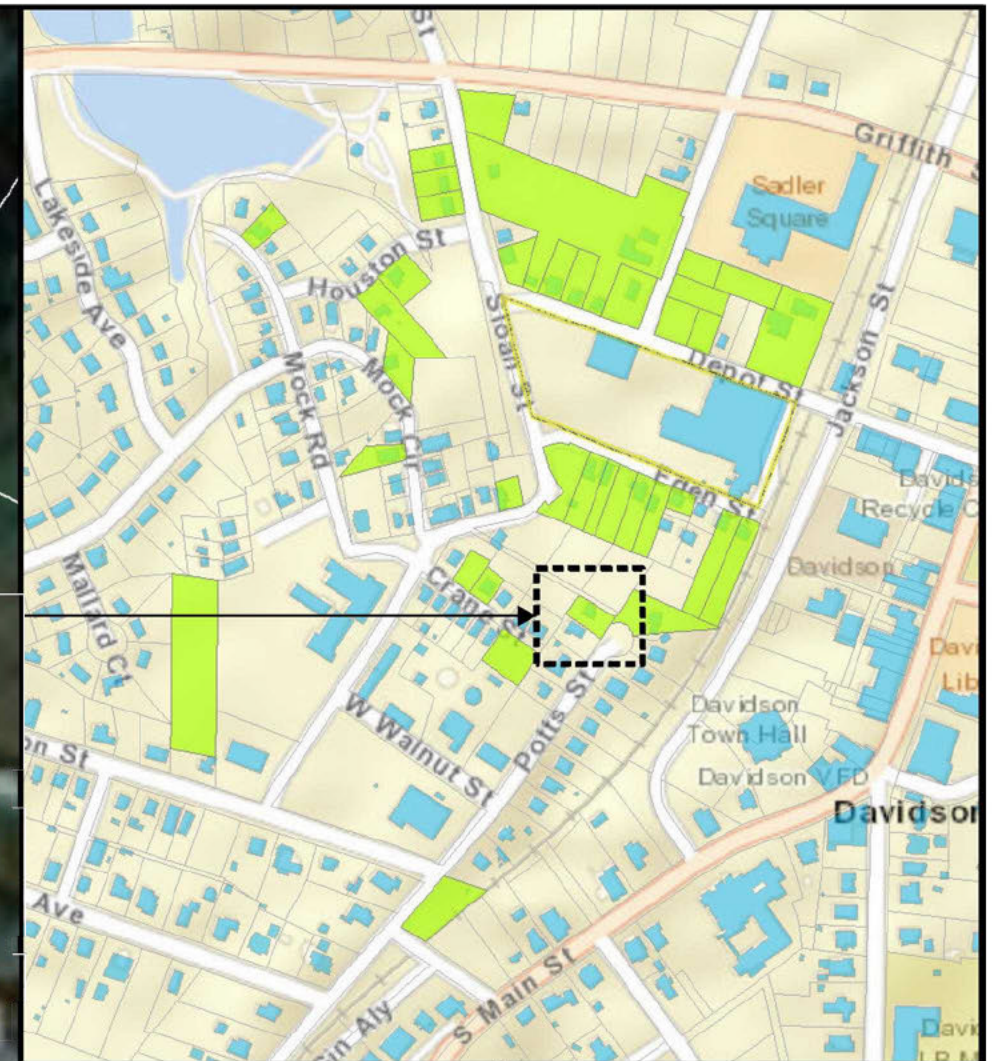
### FIGURE 1

Removal Areas and  
Air Sampling Locations

**Description of Removal Action:** The soil was excavated to an approximate maximum depth of 12 inches in the lawn 2 inches around the tree and shrub line areas (see Appendix 1). Visual inspections of the areas excavated for ACM were conducted by a State of North Carolina-accredited asbestos inspector and air monitor. Additional removal was conducted in those areas where ACM were still visibly present. Once ACM was no longer visibly present, restoration of the excavated areas was allowed to commence.
